REPORT: T021056-G1

CITY OF BROCKVILLE
CONDITION INSPECTION
BROCKVILLE RAILWAY TUNNEL
BROCKVILLE, ONTARIO

November 8, 2012

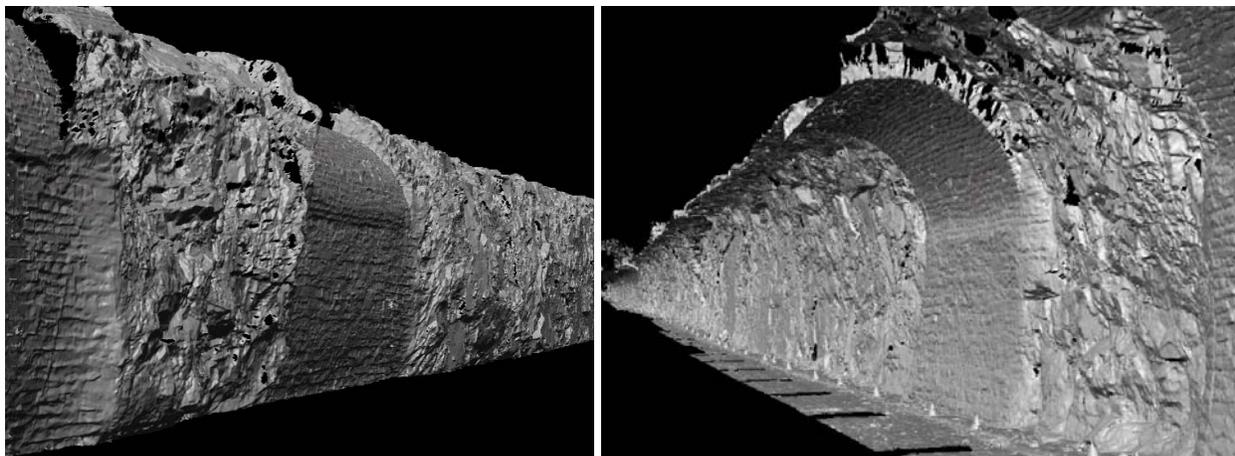
Lidar meshed models of brick/rock interface at +165m. Left image is an outside view, right image is an inside view. The 2D model can be viewed from anywhere in space.

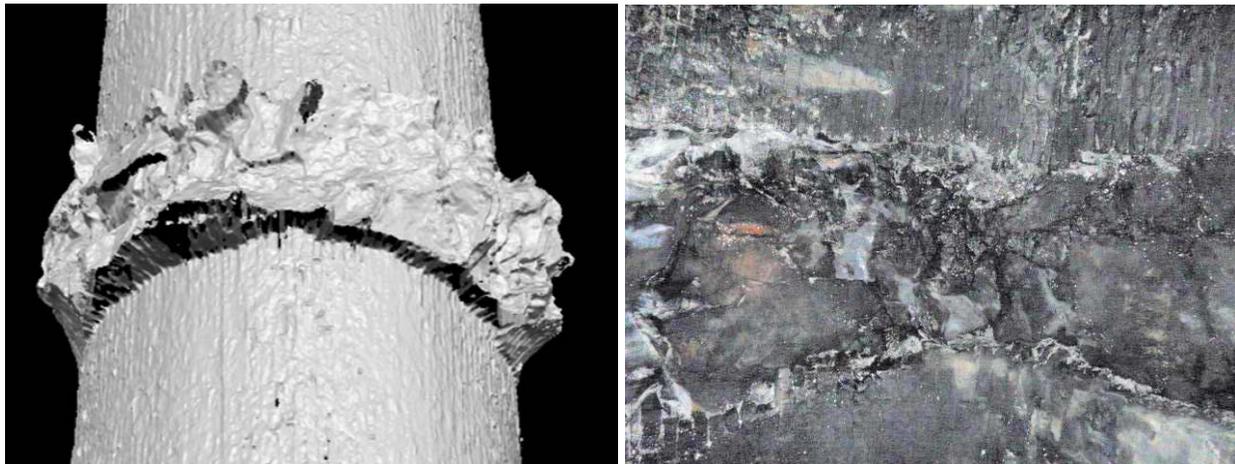
Advancing into the tunnel from the south, the first bedrock exposure that is encountered is a narrow 1m window in the brickwork (deliberately created during construction) at approximately 139m from the south portal. This rock is very blocky, fractured and weathered. Stained gouge is present inside some of the fractures. This is likely adjacent to a regional shear zone (common in the Brockville area). It would appear that this was a trial excavation finish. The brickwork resumes after this slot. This window of bedrock will require scaling. The slot is narrow enough that additional support may not be required. The brick edges on either side of the slot are in good condition and can be left as an example of the lining technique.

Lidar and photograph of the bedrock window at 139m into the tunnel from the south end.

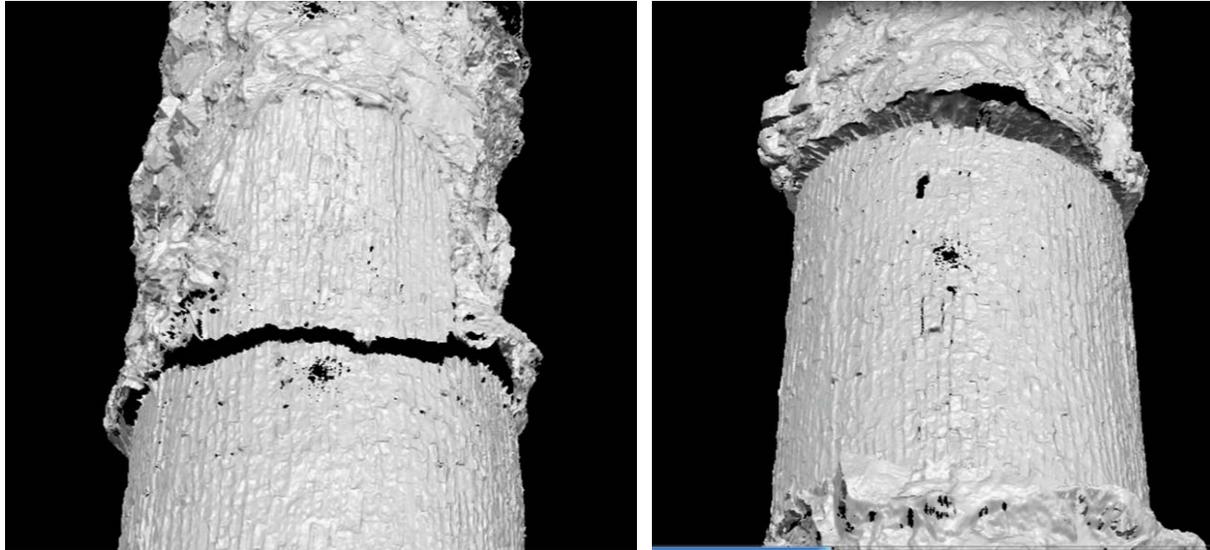
The next exposed bedrock section begins at 154m. There is a partial lining in the roof or the mortar impressions of a lining that has since been removed. This rockmass is heavily jointed with a reduction in block size. There is no immediate sign of dangerous loose but this section will require scaling and possible bolting. Evidence of a fault zone appears at the end of this section (160m). This section and the brick edge will require special attention and reinforcement. The edge of the brickwork entering and leaving this section (to 160m) will need careful inspection and possible stabilization. There is moderate inflow and some flow deposits in this section.

There is a short section of brickwork between 160m and the full exposed rock section at 167m. This is likely in response to the fault zone detected at 160m. The brick liner appears to be continuous and with limited disturbance. Horizontal offset of bricks along length of lined section is likely due to construction techniques.

The last brick section in the south ends at 167m where more evidence of the boundaries of a fault zone are present. The rockmass at the edge of the brickwork is blocky with significant enlargement of the tunnel profile. The brick edge will require some attention (backfilling with grout and pointing) for long term stabilization although this brick edge can remain exposed.

(Left) lidar image of the brick-rock interface at 154m and (right) at 160m and 167m

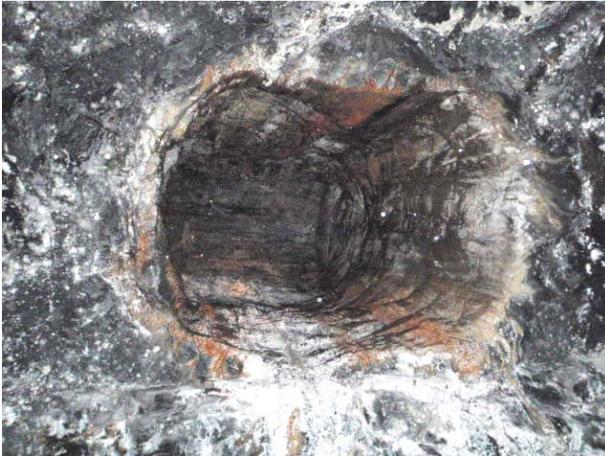
A shaft at 230m (presumably for rock removal) is in poor condition and will need stabilization. A timber cover appears at the top of the visible shaft. It is unknown what overlies this cover. The tunnel stability is not affected but the shaft itself poses a hazard and will need to be covered in some way (possible with plexiglass to allow viewing and lighting). The top of the visible shaft will require a new bulkhead. A prudent step would be to engineer a reinforced bulkhead (cast against the existing backing) anchored and positively abutted on the shaft walls with capacity to withstand equivalent surcharge loading of rock/soil (see nearest borehole for cover composition).

A shaft at 230m (presumably for rock removal) is in poor condition and will need stabilization. A timber cover appears at the top of the visible shaft. It is unknown what overlies this cover. The tunnel stability is not affected but the shaft itself poses a hazard and will need to be covered in some way (possible with plexiglass to allow viewing and lighting). The top of the visible shaft will require a new bulkhead.

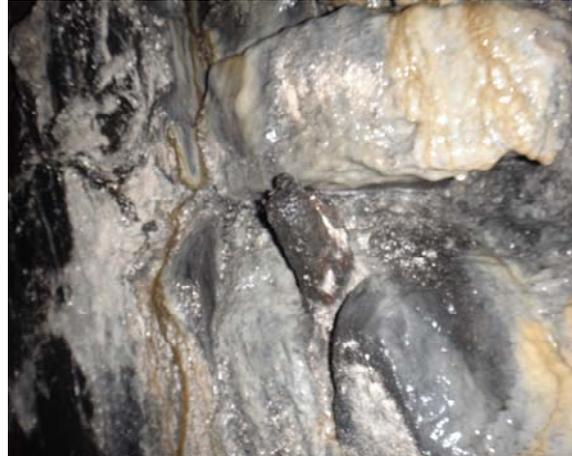
(Left) Rock Hoisting Chimney at 230m. (Right) Corroded iron bar holding brickwork at 295m

The rock section continues to 295m, with a joint controlled irregular profile and significant flow deposits, where the dug tunnel in till begins with stone brickwork. The leading edge of the brickwork at the brick-rock interface is highly irregular. The brick arch abutment climbs up on a blasted rock edge from the floor at 308m to half height at 295m. The leading edge at 295m is supported by highly corroded rockbolts from the original construction. While the rock is stable, the tapered base of the brickwork and the interface at 295m requires significant work to stabilize, buttress and replace the aging rockbolts.

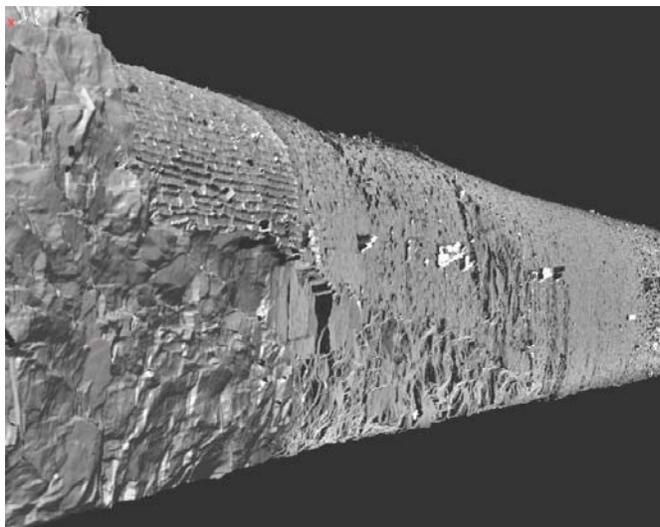
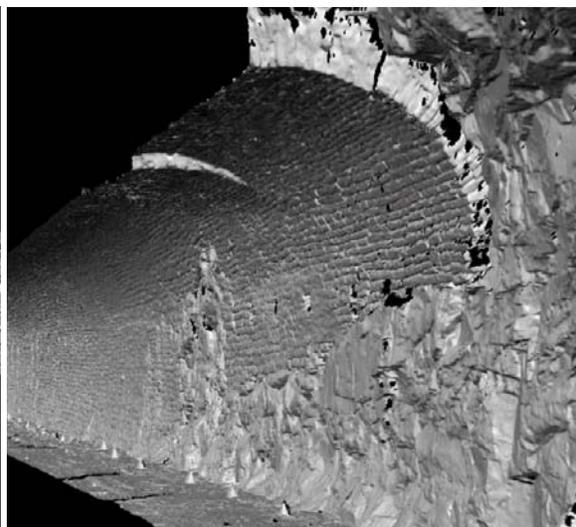
Tapered interface between rock and brickwork in northern soft tunneling section.

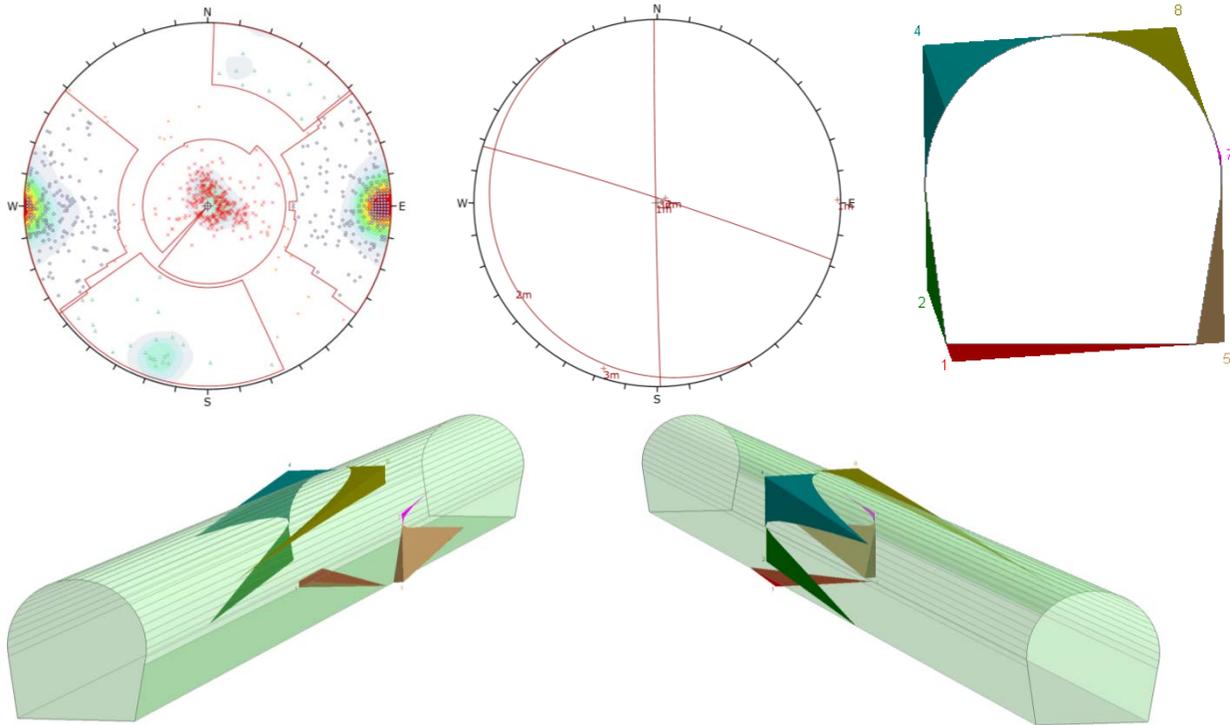
Joint sets and wedges (blocks) formed in an ideal tunnel profile. 160-200m (max localized bolt loading = 0.75 tonnes/m² of face area.)

The maximum distributed bolt load to maintain the originally intended arch profile would have been less than 1 tonne per square metre. This is equivalent to a standard grouted rebar bolt on 3x3 metre spacing assuming the unstable blocks are evenly distributed. A 2x2m spacing would give a factor of safety of greater than 2. However, most of the unstable blocks formed by this profile have already fallen out (likely at excavation). Only one location has had minor block fallout since 1970. Thus only spot bolting may be required to ensure long term stability.

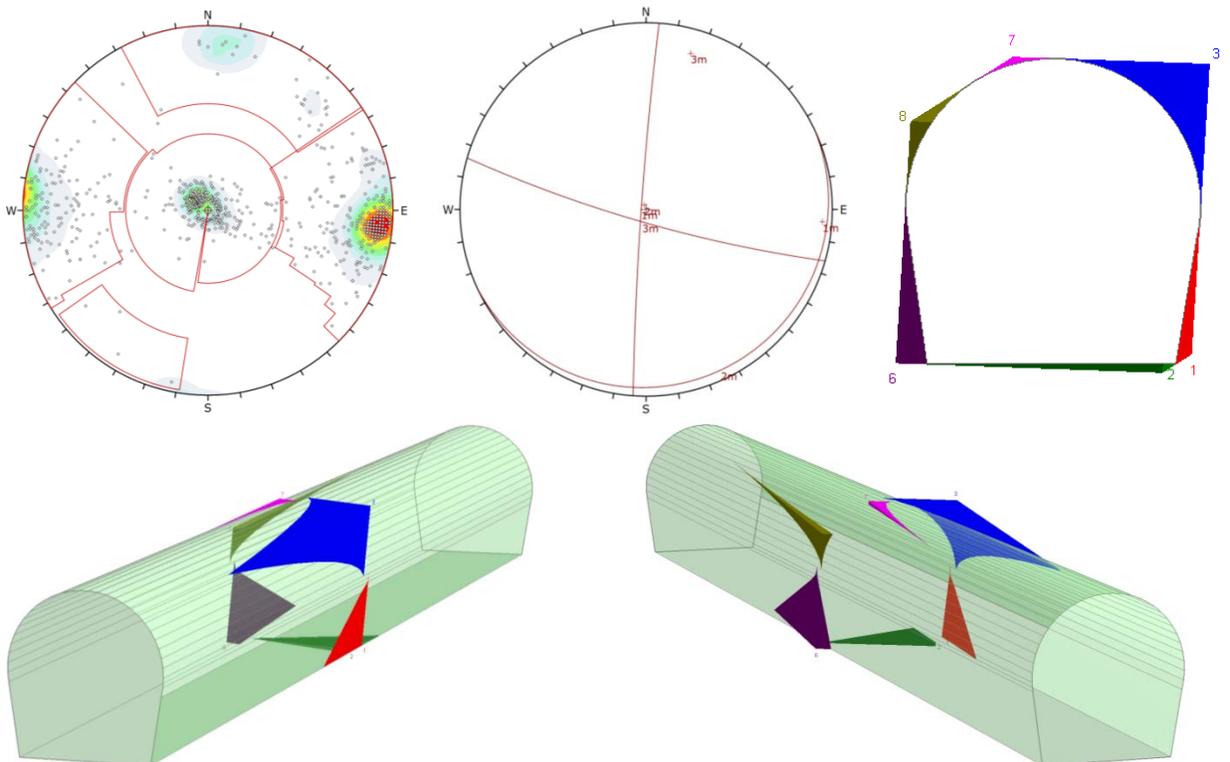
Joint sets and wedges (blocks) formed in an ideal tunnel profile. 200-240m (max localized bolt loading = 0.85 tonnes/m² of face area.)

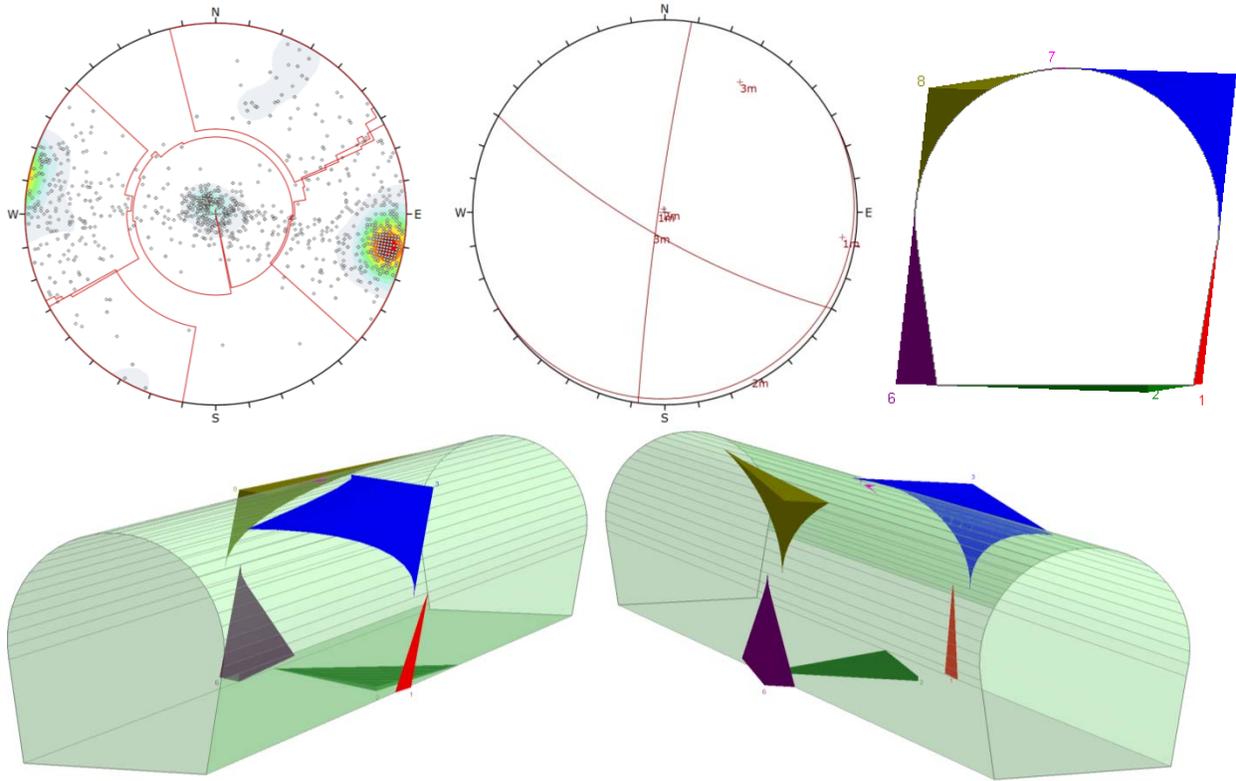
Joint sets and wedges (blocks) formed in an ideal tunnel profile. 240-290m (max localized bolt loading = 0.9tonnes/m² of face area.)

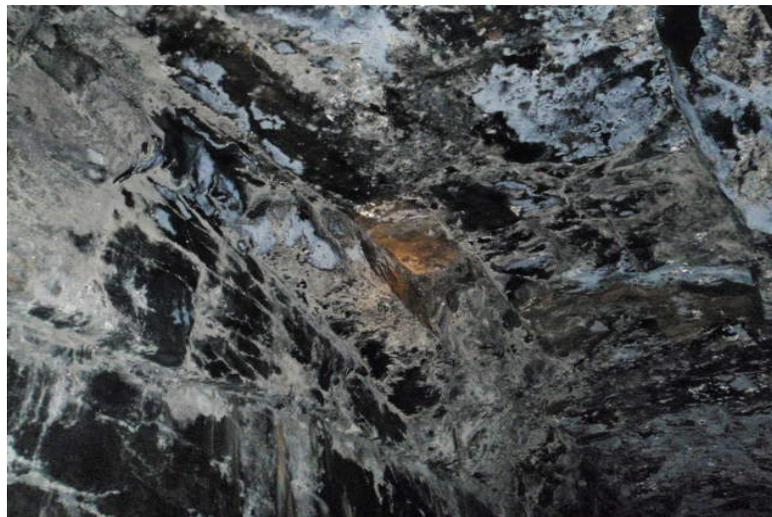
Typical horizontal and vertical structure in the roof leading to square corner.

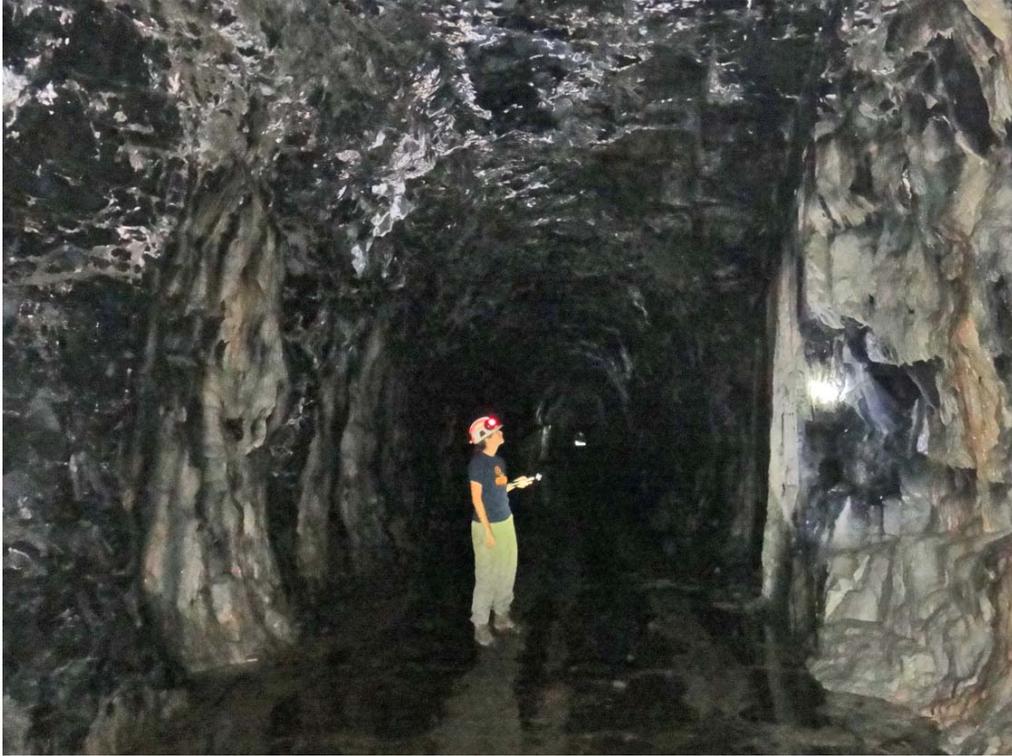
Vertical wall joints at +220m

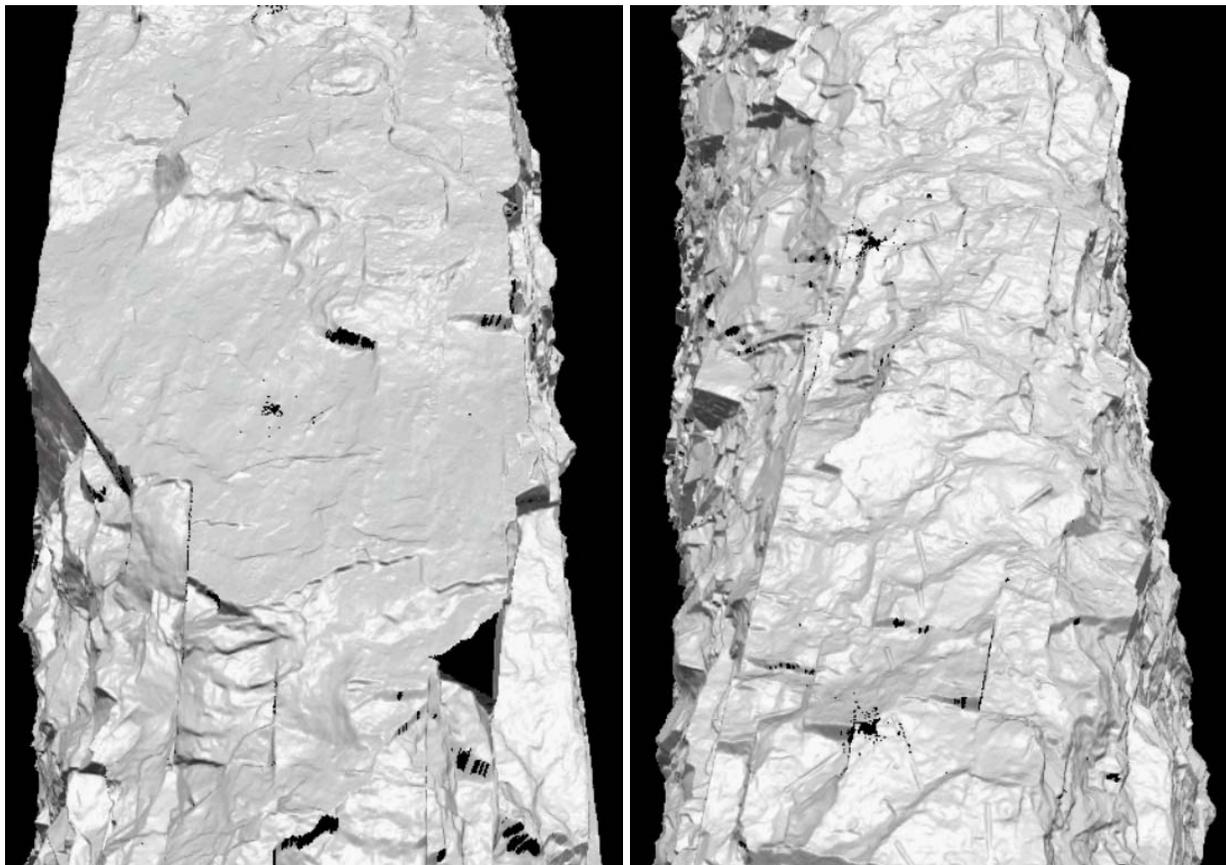
Overhead Lidar image of structural character at 205m and at 280m
